Painesville PRP Group
Non-responsive

August 7, 2012

Subject: Summary of Drainage System Maintenance, Operable Unit 20, Former Diamond
Shamrock Works Site, Painesville Ohio.

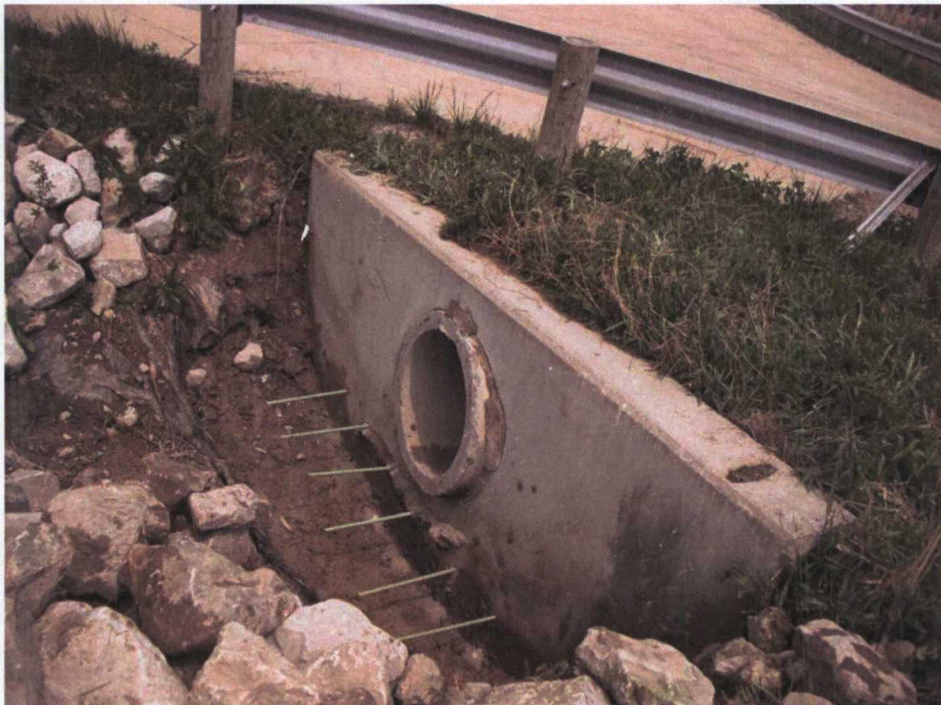
The western inlet of the 24-inch reinforced concrete pipe (RCP) that extends beneath the OU20 access road was several inches above grade. As such, a portion of storm water runoff appeared to flow beneath or around the pipe and in its backfill before discharging on the eastern side of the access road.

Photograph 1. North Storm Pipe: Preparation of area for new apron

A new concrete apron and concrete lining in the ditch was constructed to adjust the grade and direct storm water into the north storm pipe inlet on May 1, 2012. The new apron and ditch liner was constructed using flowable fill and was tied to the headwall with reinforcing bars (See attached Photograph 1 and 2). A concrete lining was extended approximately 40 feet to the west to the outfall that enters the Fairport Nursery Road ditch to help maintain flow and grade within the ditch. The rock channel protection that was previously installed at the western inlet of the north storm pipe was incorporated into the construction of the apron. No excavation of soil was needed to complete this repair. Photographs of the construction of the new apron are provided as Photograph 1 through 8.

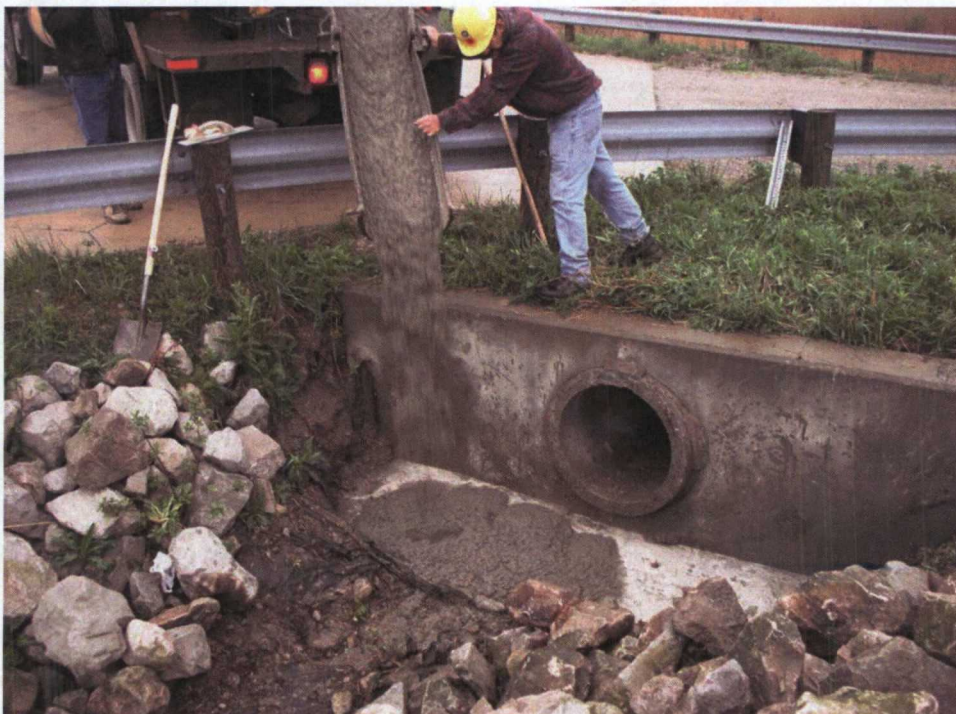
Photograph 2. North Storm Pipe: Construction of new apron

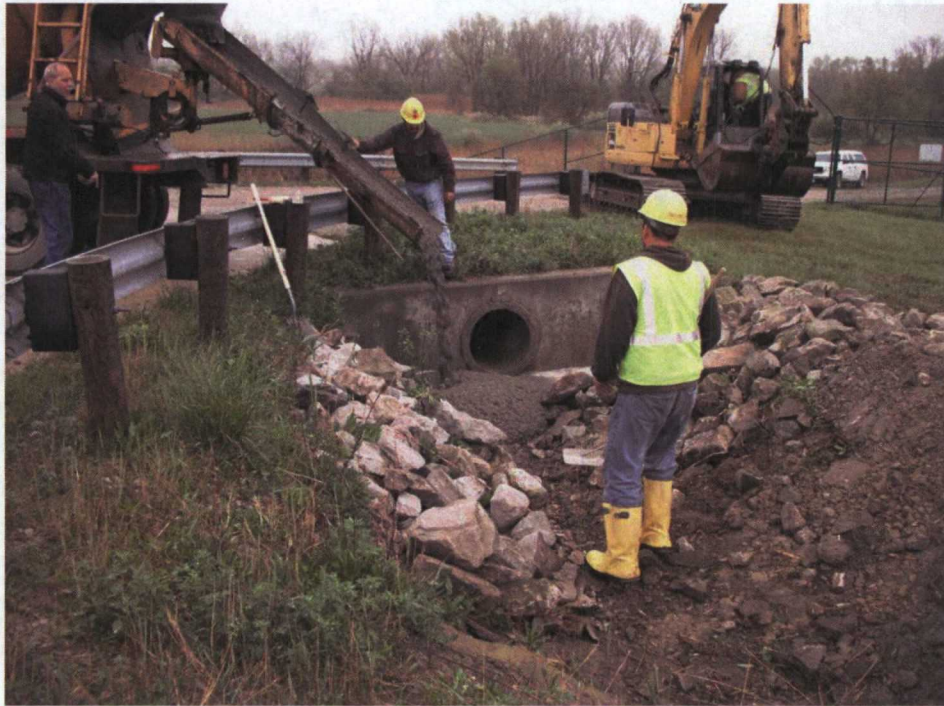
Photograph 3. North Storm Pipe: Construction of new apron

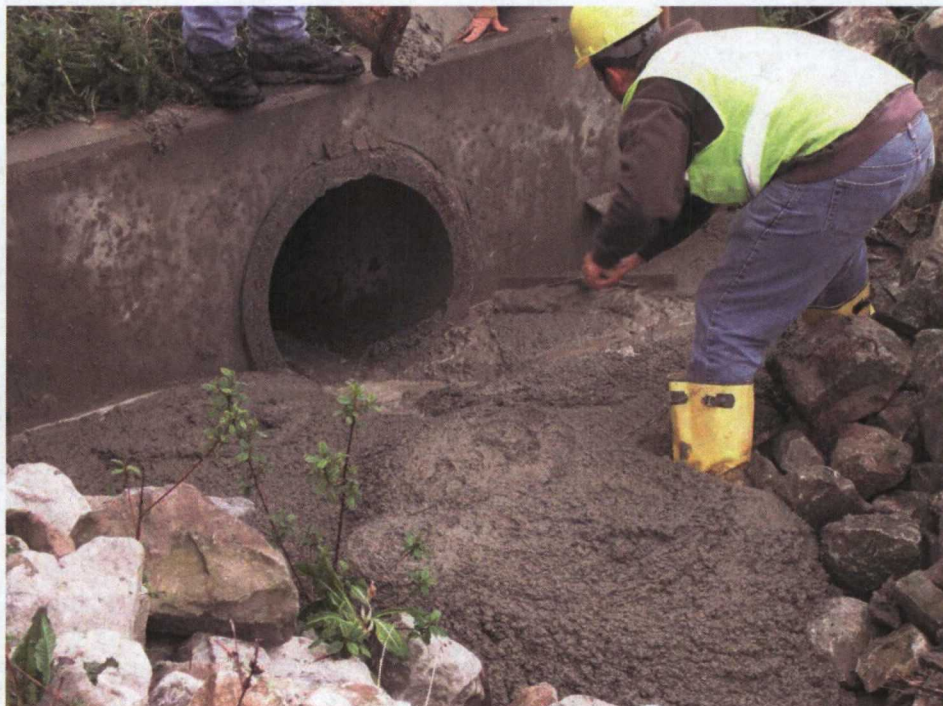
Photograph 4. North Storm Pipe: construction of new apron

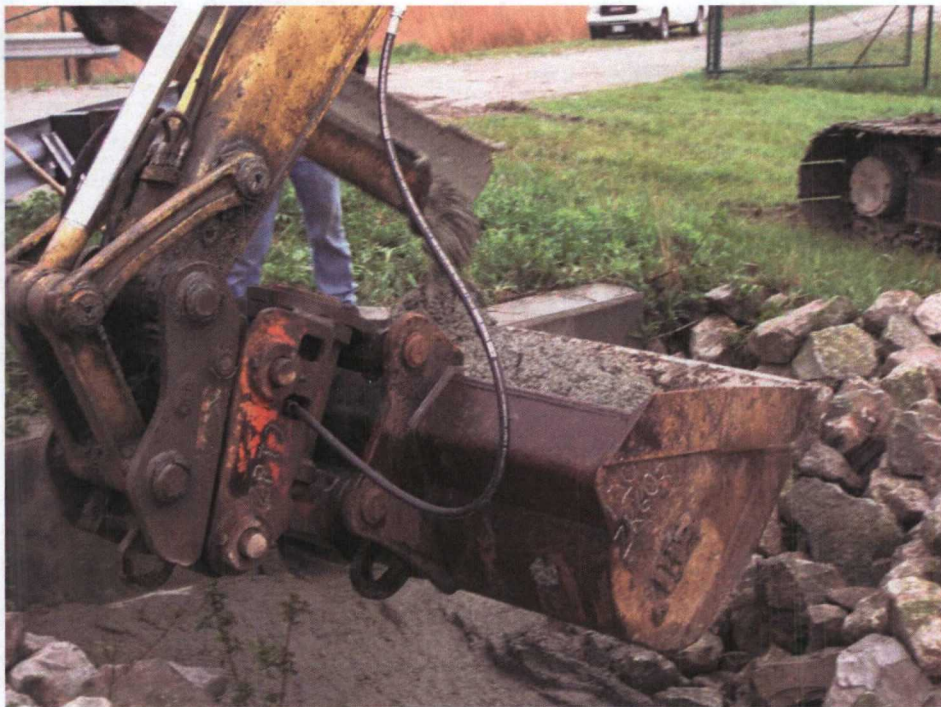
Photograph 5. North Storm Pipe: construction of new apron

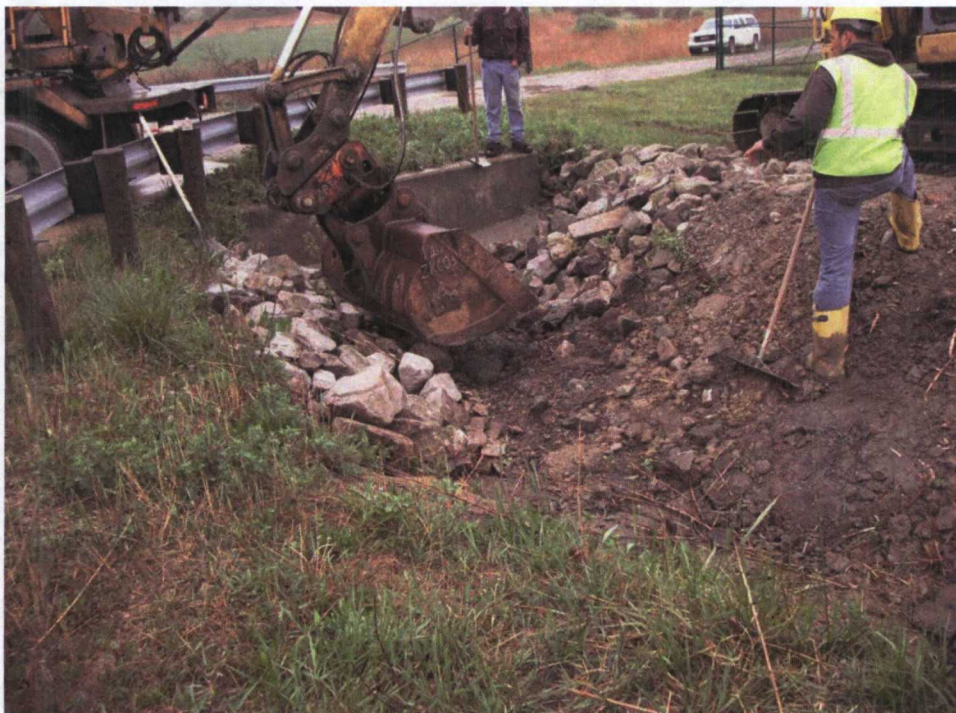
Photograph 6. North Storm Pipe: construction of new apron

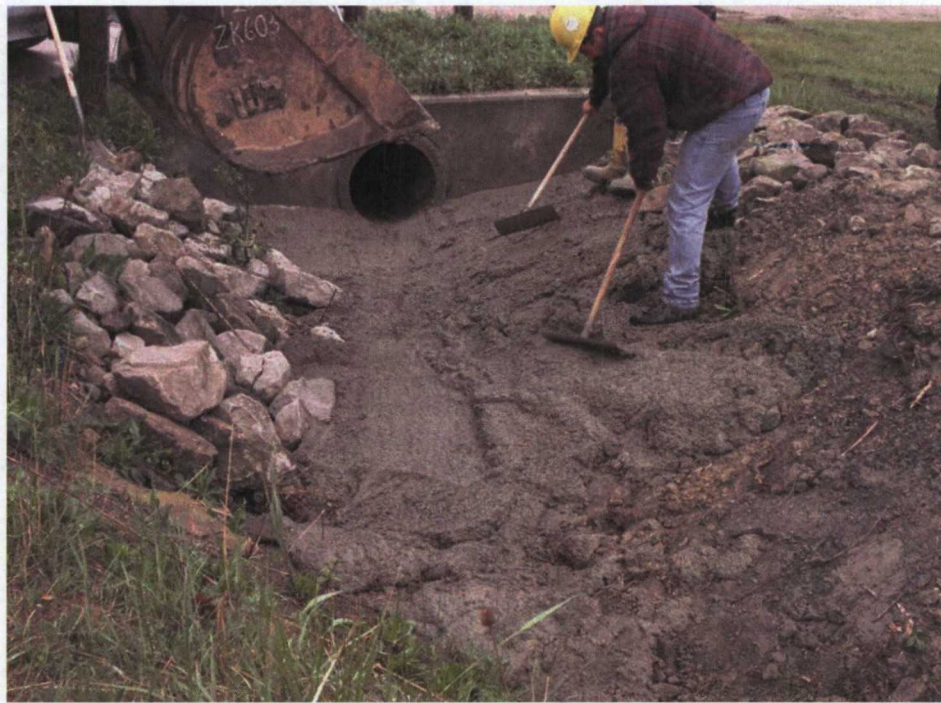
Photograph 7. North Storm Pipe: construction of new apron

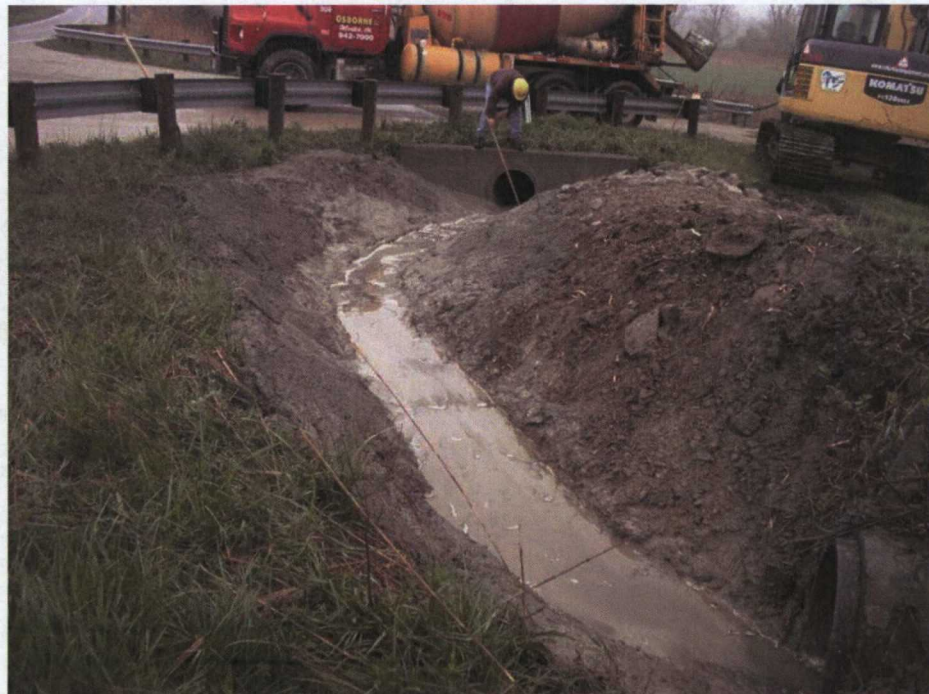
Photograph 8. North Storm Pipe: Testing flow across new apron

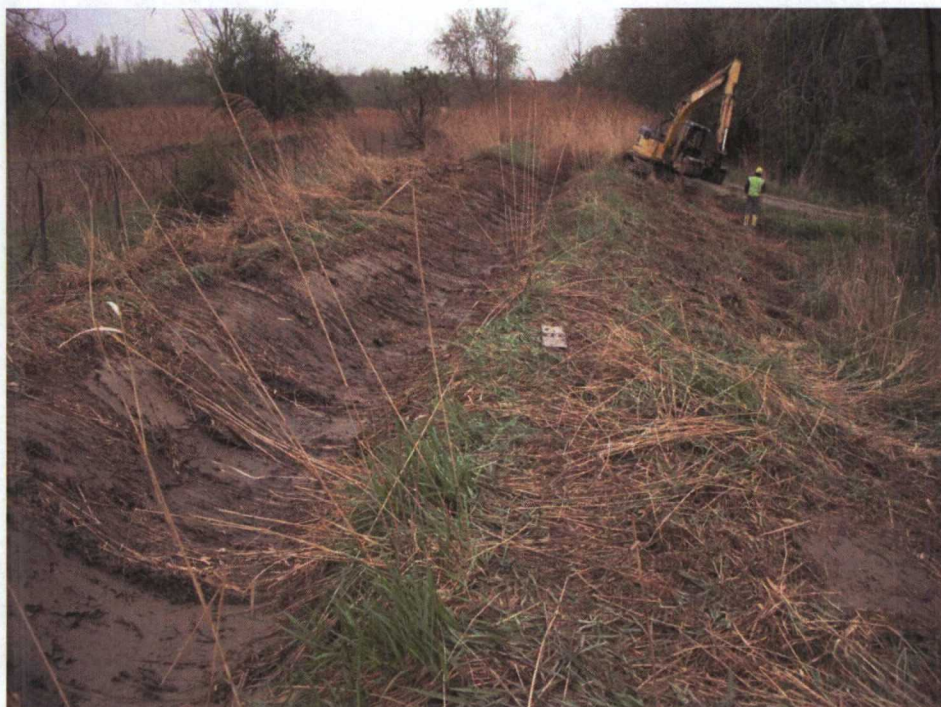
Tall vegetation and accumulation within the open sections of the east Diamond ditch hampered the flow of the storm water off of OU20. The center portion of the east Diamond ditch is covered and storm water is conveyed in a 12-inch pipe to convey storm water flow past the OU20 Groundwater Extraction System. Storm water flow through the pipe appears to be uninhibited. In the northern section of the east Diamond ditch, the east-side of the ditch channel is defined by a concrete bank. However, the ditch channel had been filled from vegetation and sedimentation. The channel is well defined in the southern portion of the east Diamond ditch but was also filled with tall vegetation.

Photograph 9. Diamond Ditch looking south: Clearing and exposing ditch south of groundwater extraction system

The vegetation within the open portions of the east Diamond ditch was cleared on May 3, 2012. This work was conducted in the open portions of the ditch from the north fence to a small culvert beneath a vehicle turn-around located approximately 50 feet north of the Grand River. The vegetation and

shallow soil from within the ditch was graded and feathered into the adjacent topography to further define the ditch (see Photographs 9, 11 and 12).

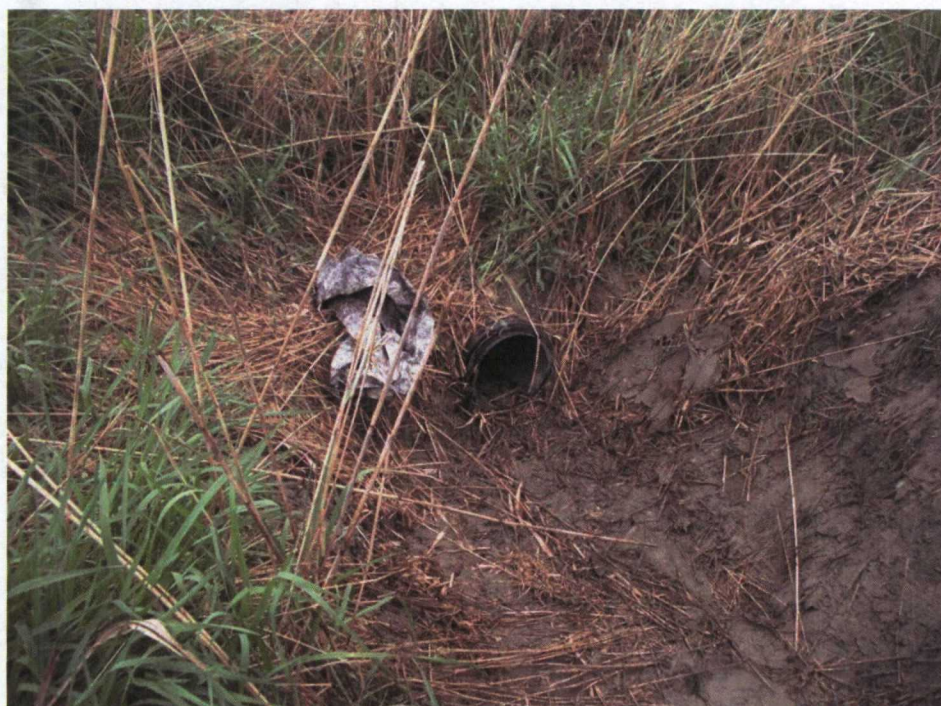
Photograph 10. Diamond Ditch: Inlet of piped portion of Diamond ditch north of groundwater extraction system.

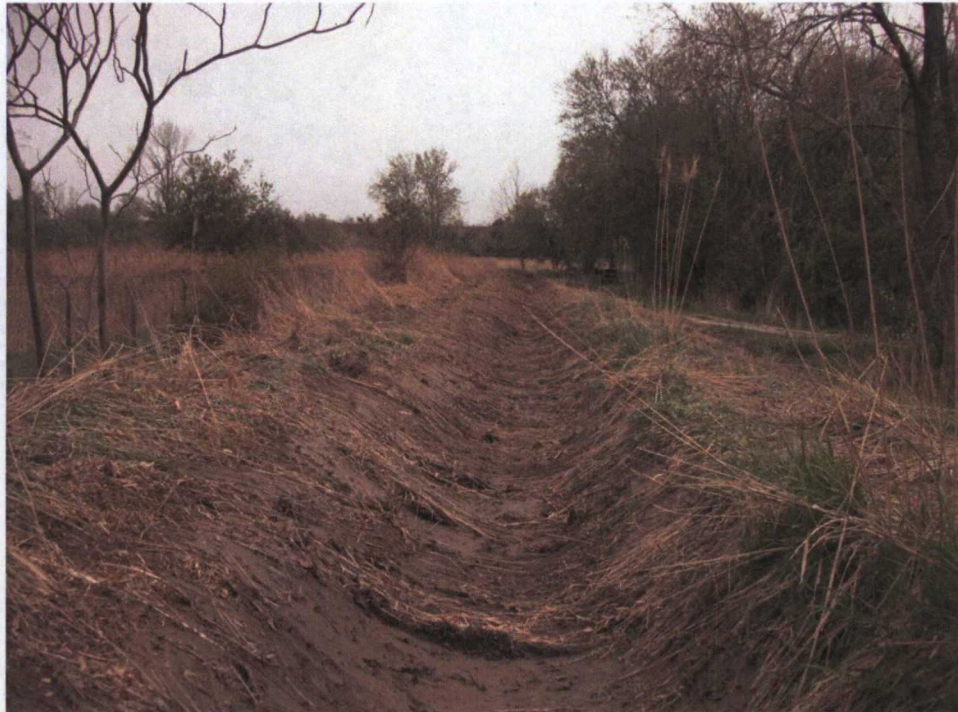
Photograph 11. Diamond Ditch looking south: Cleared and exposed ditch south of groundwater extraction system to Grand River

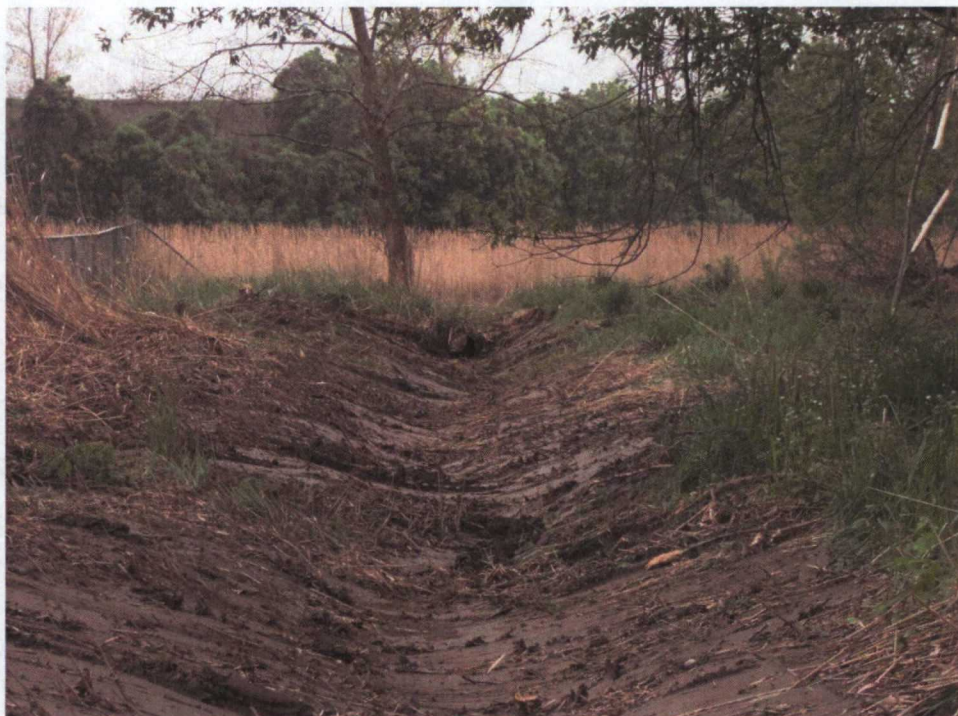
Photograph 12. Diamond Ditch looking south: Cleared and exposed ditch south of groundwater extraction system to pipe beneath vehicle turn around.

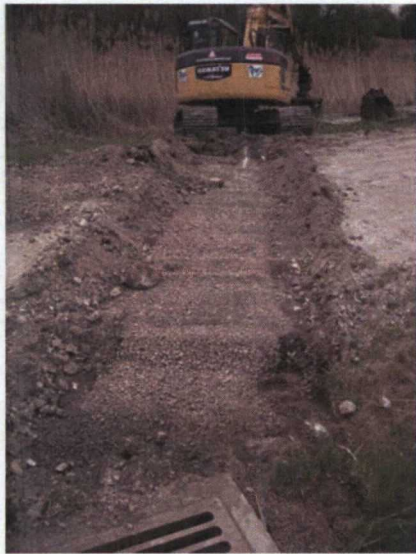
During storm events it was observed by site personnel that water flowed into the catch basin and 12-inch RCP on the western side of the road. However, based on qualitative observations the volume of the water entering the catch basin on the west side of the access road was not equal to the water exiting on the east side. Therefore it appeared that storm water was infiltrating beneath the road. When exposed during excavation the pipe was found to consist of several smaller pieces of RCP joined together. The storm pipe was replaced and extended to directly connect into the covered pipe portion of the east Diamond ditch. The repair activities were conducted on May 7 and May 9, 2012. No work was conducted on May 8, 2012 due to weather conditions.

Photograph 13. Center Access Road Storm Pipe. Gravel road removed.

The existing pipe was excavated and a new smooth-walled HDPE pipe was installed into the trench. The rock in the old pipe outfall was removed and a shallow trench was extended from the old pipe outfall to the existing east Diamond ditch pipe. The gravel road material and top soil were scraped off and segregated for re-use (see Photograph 13). Excavated soil was stockpiled on liners adjacent to the areas being excavated to use as backfill after pipe replacement and installation (see Photograph 18). No additional soil was required for backfilling. As indicated above, no COPR, fly ash or milk of lime settling material was observed during the excavation.

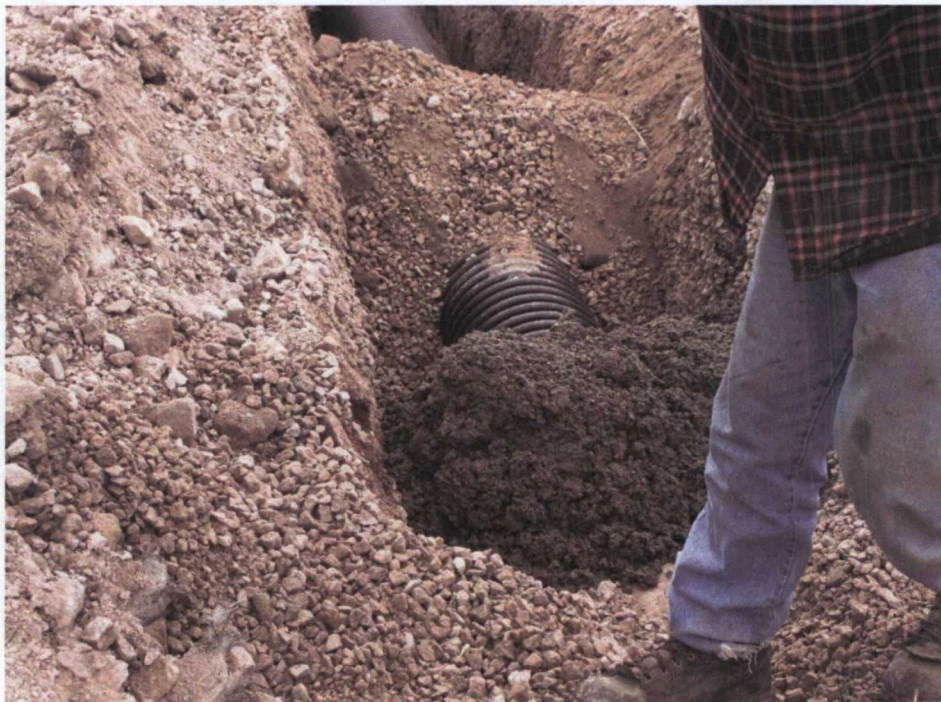
Photograph 14. Center Access Road Storm Pipe: Installation of concrete boot to protect connection to existing pipe.

2. A short section of the existing RCP was mortared into place to the catch basin. Based on inspection during the repair work it was found to be in good condition. Therefore a gasketed HDPE pipe (bell-and-spigot) was installed onto the short RCP pipe connected to the catch basin. This connection was further secured with stainless steel bands and a concrete "boot" was then poured and shaped over the joint.

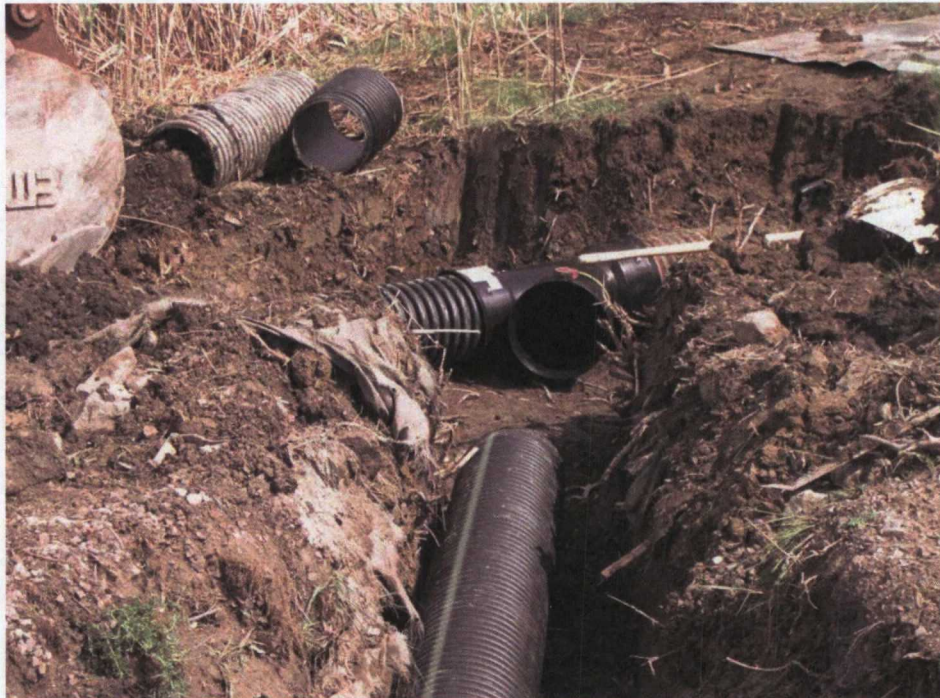
Photograph 15. Center Access Road Storm Pipe: Installation of wye connection to Diamond Ditch pipe.

The new HDPE pipe was extended from the catch basin connection and joined to the existing east Diamond ditch pipe using a wye connector pipe (see Photographs 15 through 17). The portion within the access road was backfilled with 304 limestone and compacted with a hydraulic machine mounted compactor. The remaining portion of the pipe and excavation was backfilled with excavated soil and tamped in place (see Photographs 19 and 20).

3. A small piece of the existing East Ditch pipe was removed to allow for an HDPE "Y" (clean-out or wye) pipe to be installed. The third leg of the Y pipe was oriented to line up with the new HDPE pipe installed beneath the access road. The connections were connected similar to above with gasketed bell-and-spigot type connections and secured by stainless steel bands.

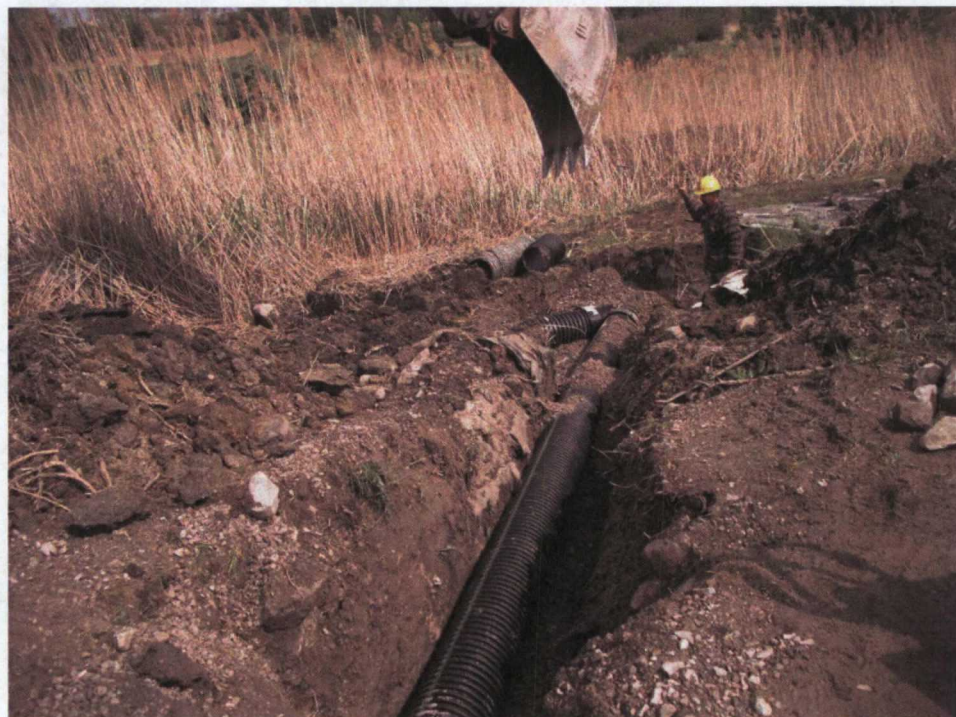
Photograph 16. Center Access Road Storm Pipe: Center Access Road Pipe connected to existing Diamond ditch pipe and backfilling.

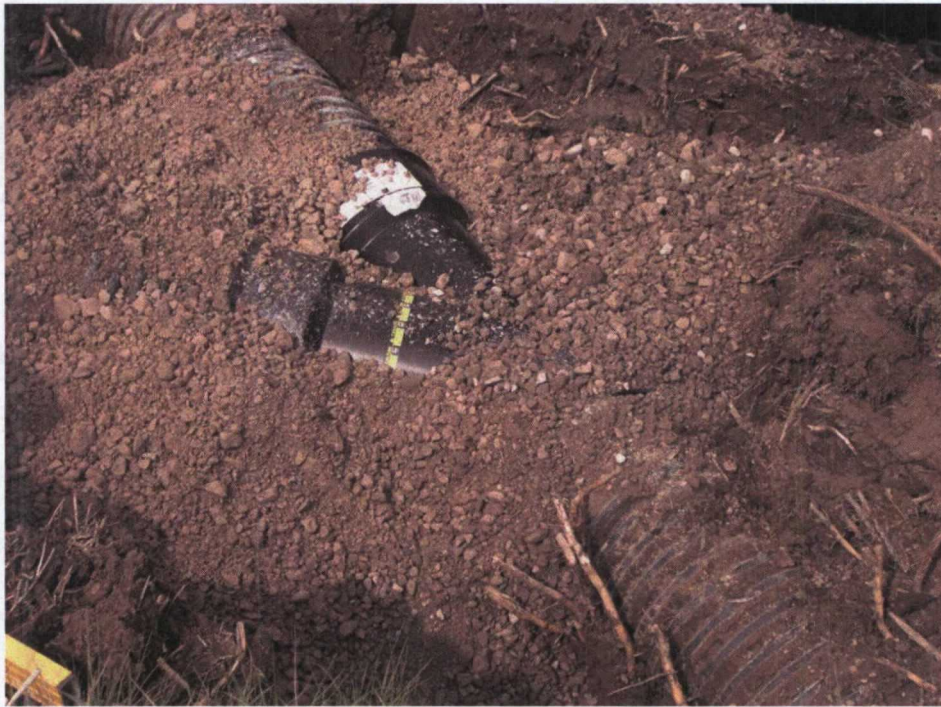
Photograph 17. Center Access Road Storm Pipe: Connection of Center Road Pipe with Diamond Ditch Pipe partially backfilled.

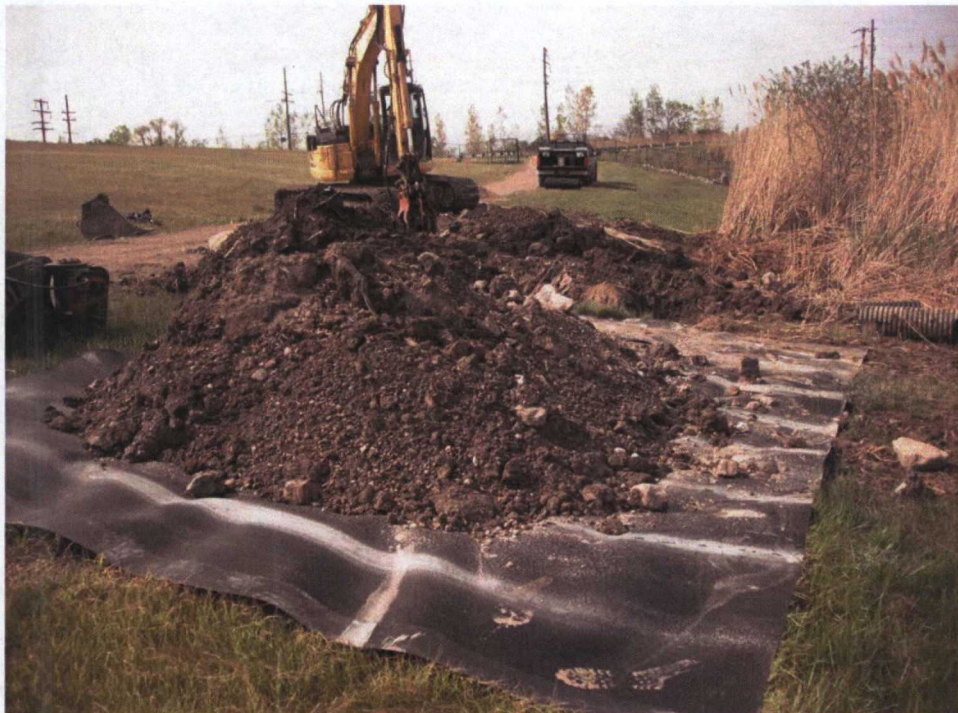
Photograph 18. Center Access Road Storm Pipe: Excavated soil stockpile

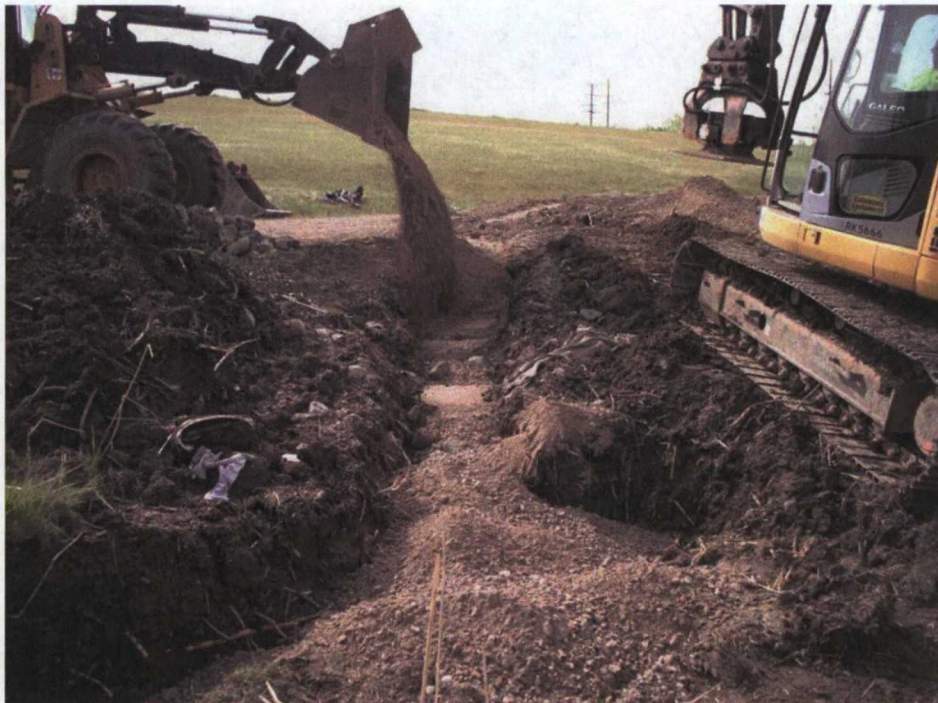
Photograph 19. Center Access Road Pipe looking west: Backfilling and compacting over new storm pipe.

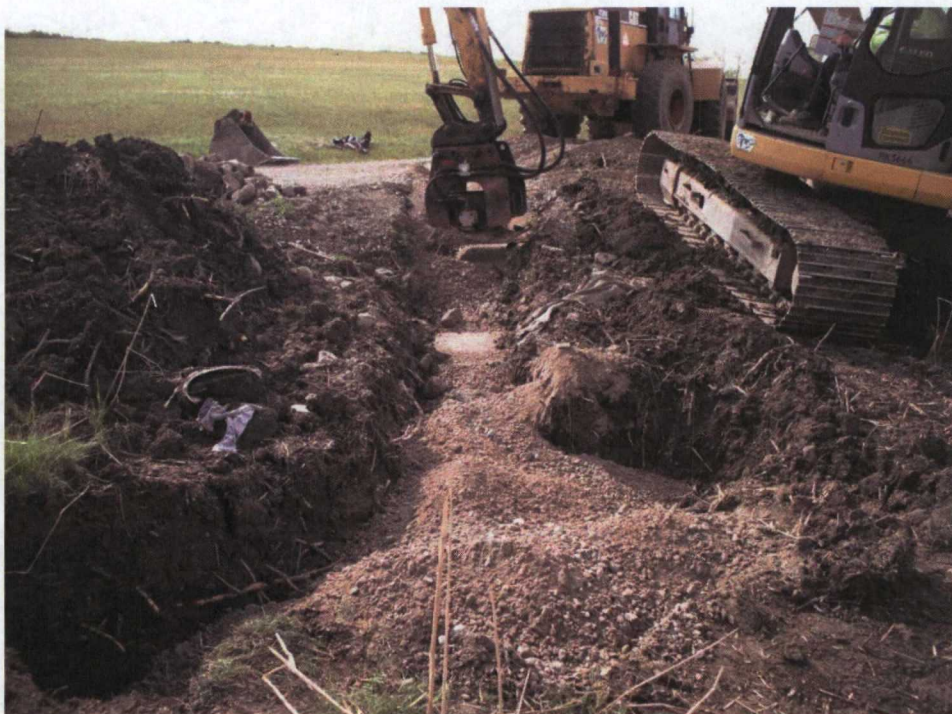
Photograph 20. Center Access Road Pipe looking west: Backfilling and compacting over new storm pipe.

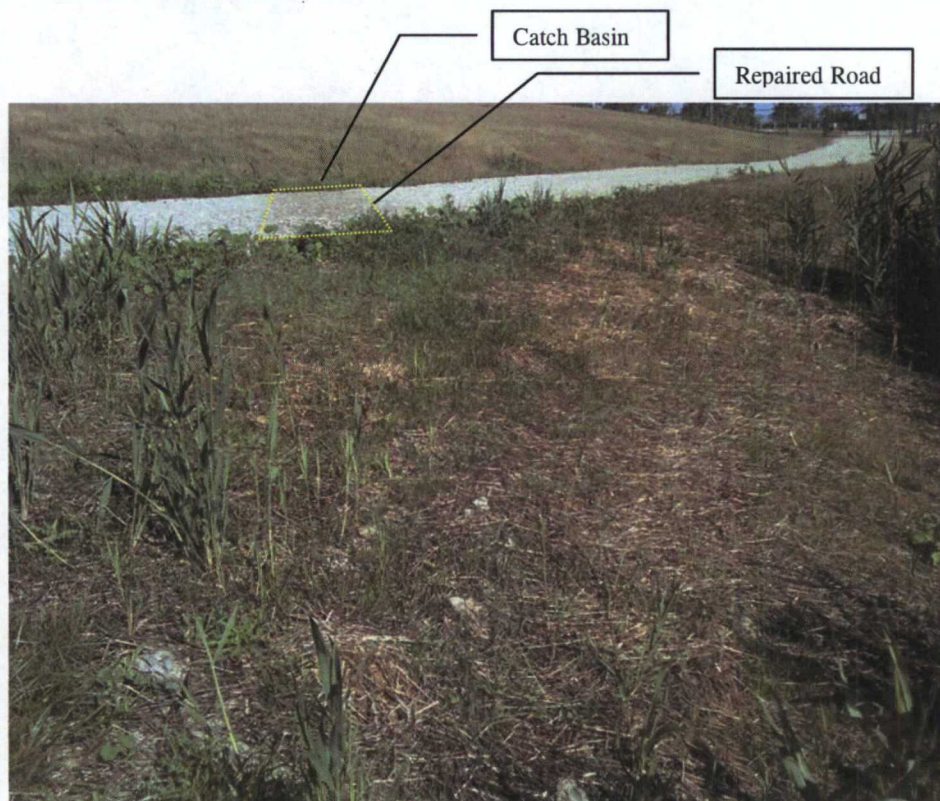
Photograph 21. Center Access Road Pipe: Restored area (August 1)

After backfill has been placed, the gravel road surface was replaced. In other areas, approximately 6-inches of top soil was placed over the work area and feathered into the adjoining areas. The areas receiving topsoil and other vegetated areas disturbed during the maintenance activities were seeded to
